# Shoreline Situation Report NEW KENT, KING WILLIAM, AND KING and QUEEN COUNTIES

Chesapeake Research Consortium Report Number 44  
Special Report In Applied Marine Science and Ocean Engineering Number 99 of the

VIRGINIA INSTITUTE OF MARINE SCIENCE  
Gloucester Point, Virginia 23062

1975

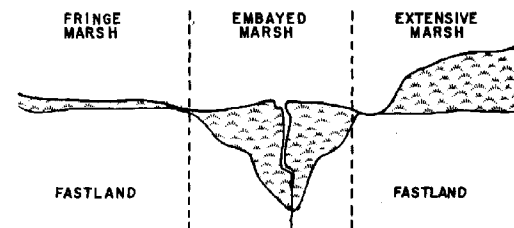
FIGURE 2: A generalized illustration of the three different marsh types.

The physiographic character of the marshes has also been separated into three types (see Figure 2). Fringe marsh is that which is less than 400 feet in width and which runs in a band parallel to the

shore. Extensive marsh is that which has extensive acreage projecting into an estuary or river. An embayed marsh is a marsh which occupies a reentrant or drowned creek valley. The purpose in delineating these marsh types is that the effectiveness of the various functions of the marsh will, in part, be determined by type of exposure to the estuarine system. A fringe marsh may, for example, have maximum value as a buffer to wave erosion of the fastland. An extensive marsh, on the other hand, is likely a more efficient transporter of detritus and other food chain materials due to its greater drainage density than an embayed marsh. The central point is that planners, in the light of ongoing and future research, will desire to weight various functions of marshes and the physiographic delineation aids their decision making by denoting where the various types exist.

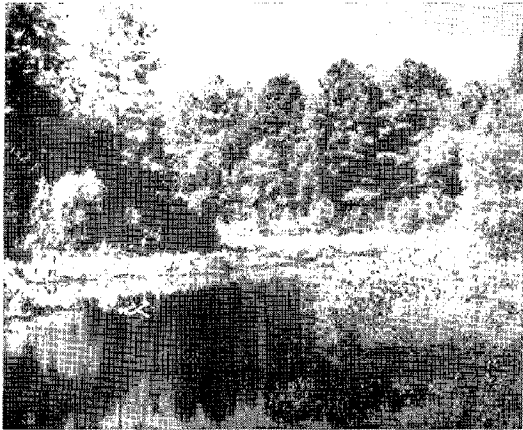
Figure 3

FIGURE 3: A portion of Diascund Creek in New Kent County. This is a very valuable area of fresh water wetlands.

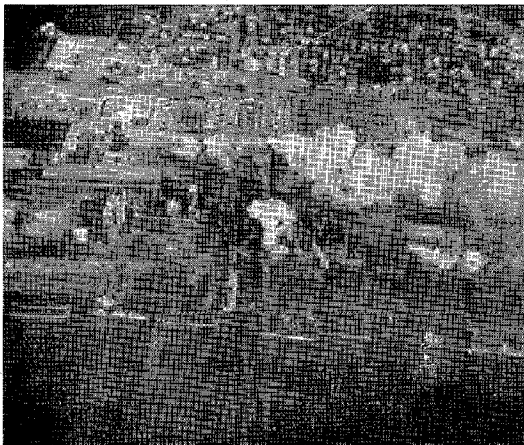
Figure 6

FIGURE 6: The Pamunkey River near its mouth at West Point. This is the only industrial area along the tri-county shore zone.

The residential and industrial growth in the West Point area has put ever increasing pressure on the shorelands of this area. The Chesapeake Corporation facility has artificially stabilized its shoreline to provide access for the freighters and barges which transport its products and supplies. These structures replaced the wetlands which previously protected the shore from erosion. Until the implementation of the Virginia Wetlands Law of 1972, the residential development along the West Point peninsula had severely encroached on the wetlands. Erosion protection capabilities were thus reduced or eliminated which necessitated installation of structures to control erosion. The existing structures at the end of the peninsula are doing a good job of protecting the shore. In the future, such marsh areas should be encouraged to grow. In critical areas, a replanting program should be instituted to replace the marshes. Their natural erosion and flood protection capabilities make them a good selection when addressing the protection of the shoreline in this area.

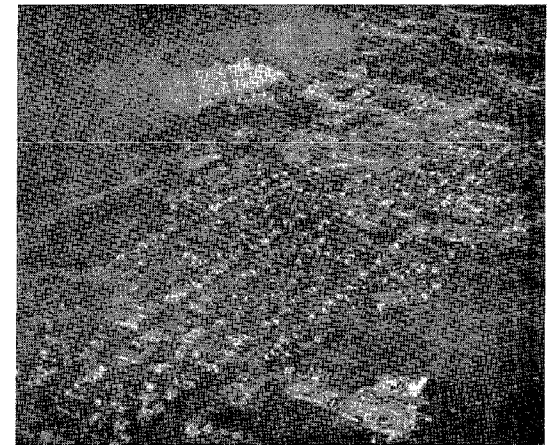
Figure 7

FIGURE 7: An overview of the city of West Point from the Mattaponi River across to the Pamunkey.

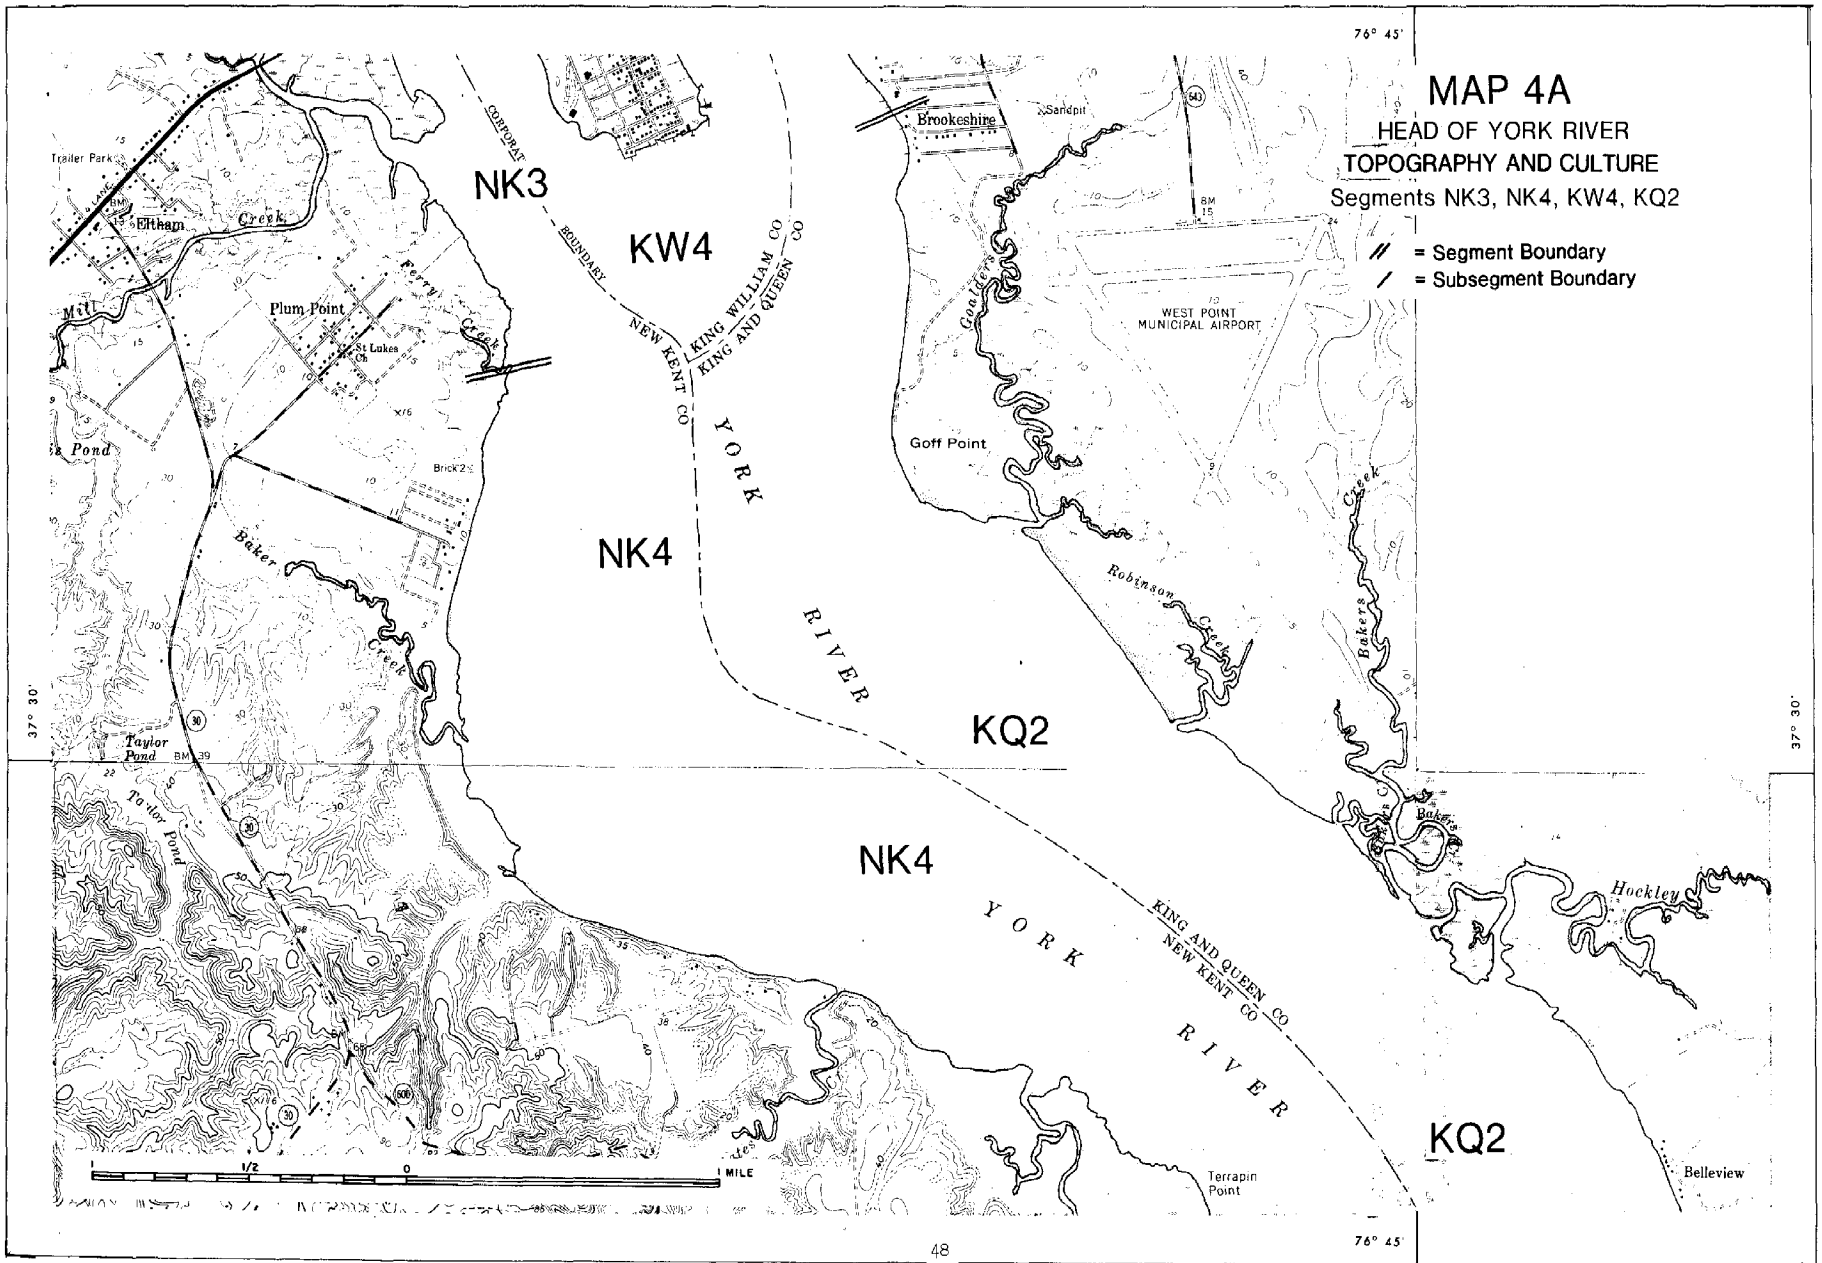
# MAP 4A

HEAD OF YORK RIVER  
TOPOGRAPHY AND CULTURE  
Segments NK3, NK4, KW4, KQ2

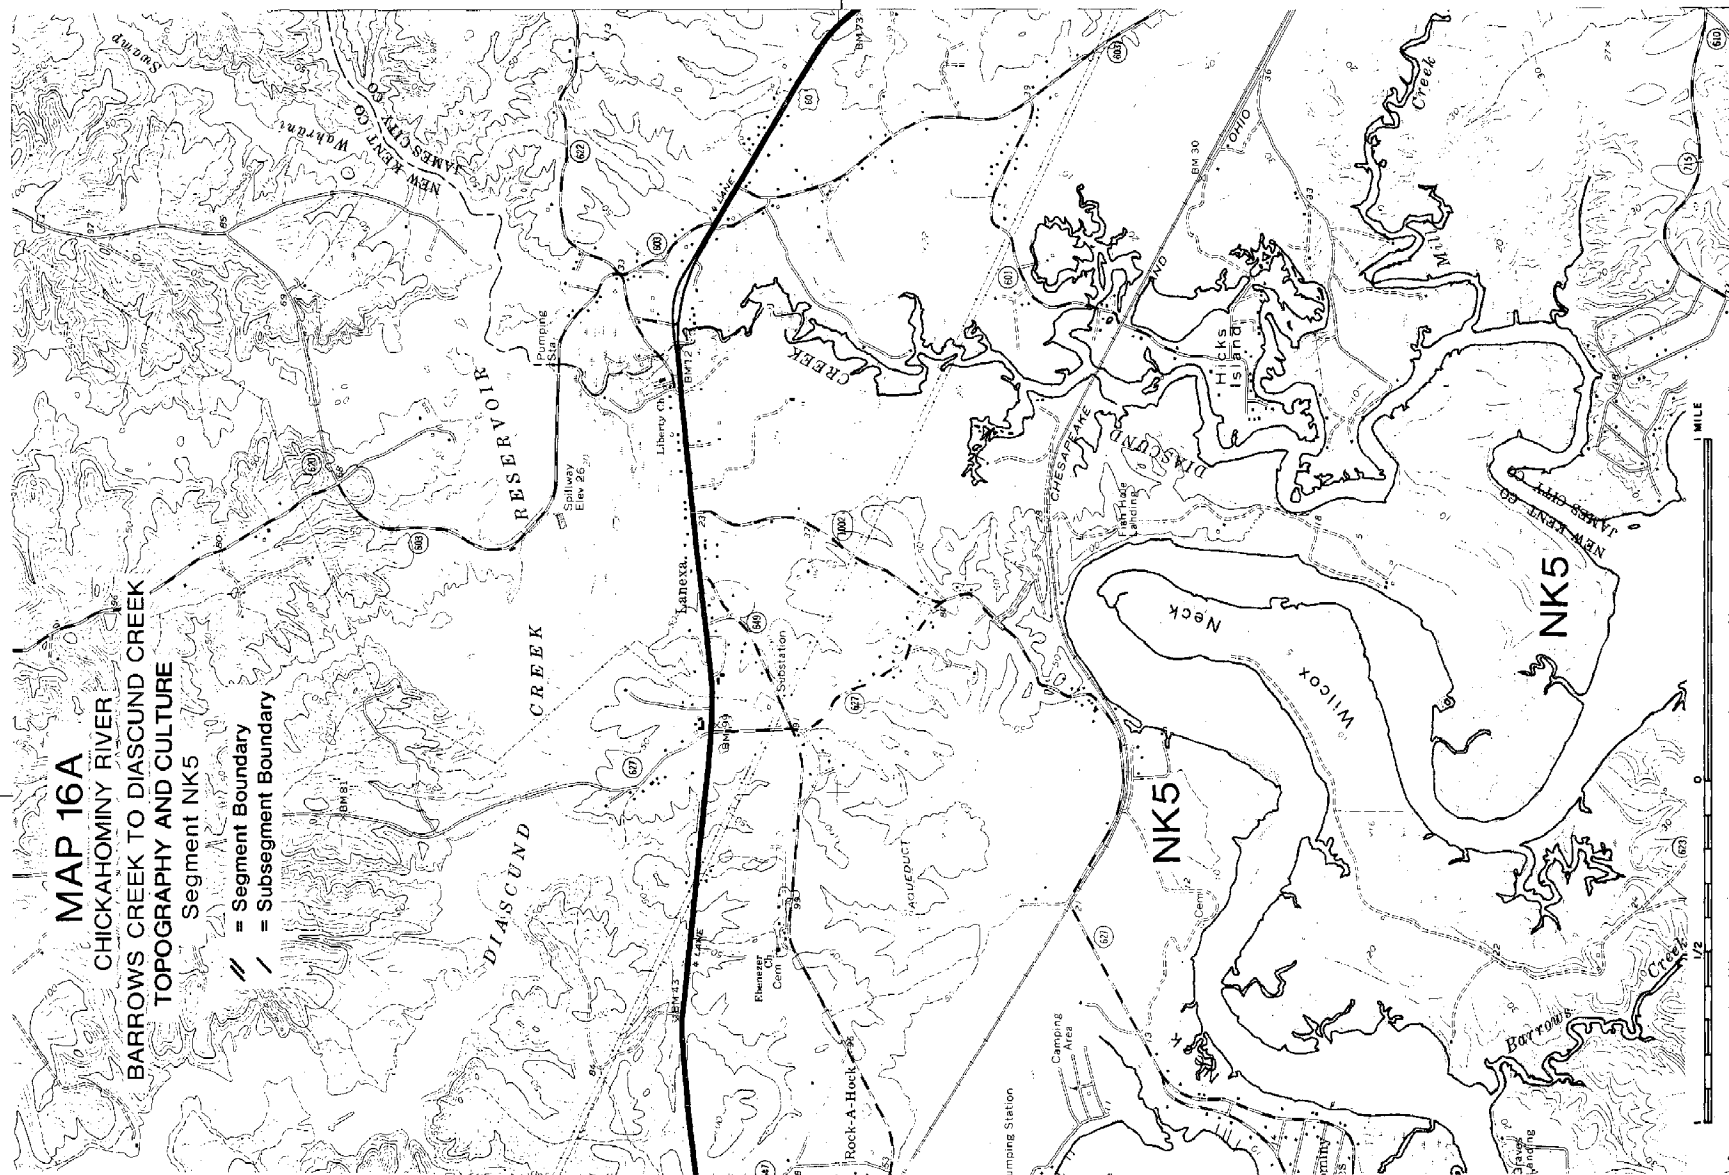
CHICKAHOMINY RIVER  
BARROWS CREEK TO DIASCUND CREEK  
TOPOGRAPHY AND CULTURE  
Segment NK5
